**Structural Control
Quarterly Inspection**

City of Mobile MS4

Facility ID	Facility Name	Address	Latitude / Longitude
UDR-SC-01	Dredge Spoils Site	3567 Wooley Road	30.61829000 / -88.12593100
Location	Watershed	Land Use	
Public Property	Upper Dog River	Other: Detention area/possible lay-down yard	
Structure Type	Outlet Type		
Retention Pond (Wet)	Pipe

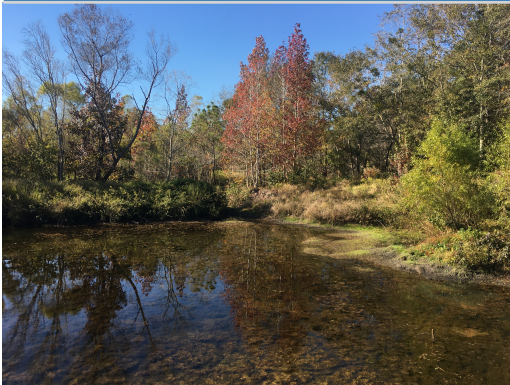
Inspector	Ludwig	Inspection Date	12/1/2021 7:00:00 PM			
Floatables Present	Litter Present	Sediment Accumulation	Debris Accumulation	Outlet Structure Clogged	Outlet Struct. Damaged	Poor Ground Cover
N	N	N	N	N	N	Y
Illegal Discharges	Illegal Dumping	Public Hazards	Other	Comments		
N	N	N	N	During inspection Public Works has been re-stablizing site with topsoil and grass seed.

Action	Deficiencies noted and maintenance required					
Remove Floatables	Remove Litter	Remove sediment	Remove Debris	Repair Outlet Structure	Repair Ground Cover	Rmv Illegal Discharges
N	N	N	N	N	Y	N
Rmv Illegal Dumping	Address Public Hazards	Other	Maint. Request Submitted	Comments		
N	N	N	N	Engineering is going to follow up to ensure Public Works properly re-seed/stabilized the area.

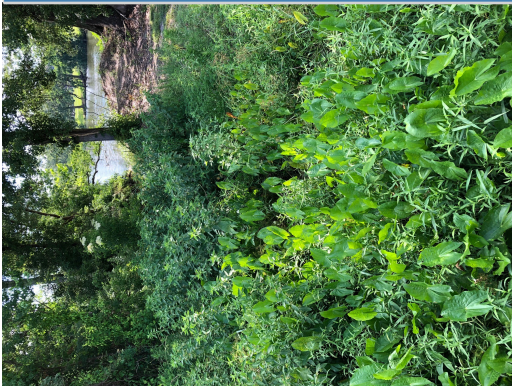
Inspector	Smith	Inspection Date	6/6/2022 9:00:00 PM			
Floatables Present	Litter Present	Sediment Accumulation	Debris Accumulation	Outlet Structure Clogged	Outlet Struct. Damaged	Poor Ground Cover
N	N	N	N	N	N	N
Illegal Discharges	Illegal Dumping	Public Hazards	Other	Comments		
N	N	N	Y	Vegetation needs to be cut.

Action	Deficiencies noted and maintenance required					
Remove Floatables	Remove Litter	Remove sediment	Remove Debris	Repair Outlet Structure	Repair Ground Cover	Rmv Illegal Discharges
N	N	N	N	N	N	N
Rmv Illegal Dumping	Address Public Hazards	Other	Maint. Request Submitted	Comments		
N	N	Y	Y	Vegetation needs to be cut.

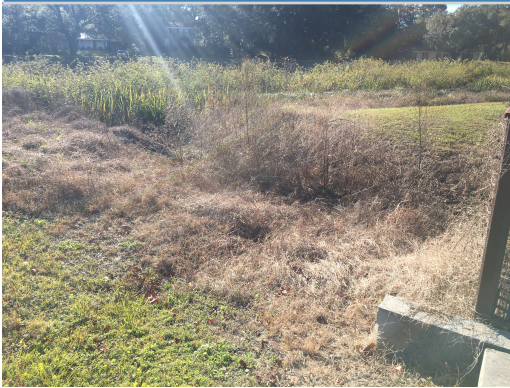
Inspector	Ludwig	Inspection Date	12/1/2021 3:00:00 PM			
Floatables Present	Litter Present	Sediment Accumulation	Debris Accumulation	Outlet Structure Clogged	Outlet Struct. Damaged	Poor Ground Cover
N	N	N	N	N	N	N
Illegal Discharges	Illegal Dumping	Public Hazards	Other	Comments		
N	N	N	Y	Vegetation needs to be cut

Action	Deficiencies noted and maintenance required					
Remove Floatables	Remove Litter	Remove sediment	Remove Debris	Repair Outlet Structure	Repair Ground Cover	Rmv Illegal Discharges
N	N	N	N	N	N	N
Rmv Illegal Dumping	Address Public Hazards	Other	Maint. Request Submitted	Comments		
N	N	Y	Y	Vegetation needs to be cut

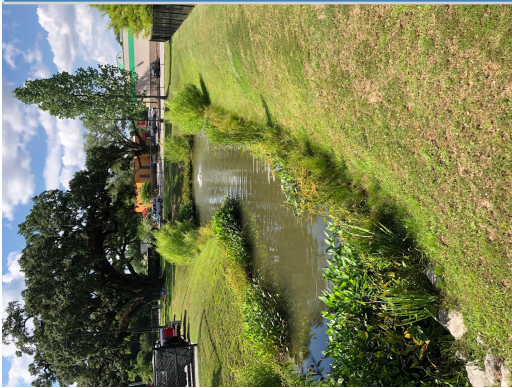
Inspector	Smith	Inspection Date	6/6/2022 8:48:00 PM			
Floatables Present	Litter Present	Sediment Accumulation	Debris Accumulation	Outlet Structure Clogged	Outlet Struct. Damaged	Poor Ground Cover
N	N	N	N	N	N	N
Illegal Discharges	Illegal Dumping	Public Hazards	Other	Comments		
N	N	N	Y	Small trees need to be cut.

Action	Deficiencies noted and maintenance required					
Remove Floatables	Remove Litter	Remove sediment	Remove Debris	Repair Outlet Structure	Repair Ground Cover	Rmv Illegal Discharges
N	N	N	N	N	N	N
Rmv Illegal Dumping	Address Public Hazards	Other	Maint. Request Submitted	Comments		
N	N	Y	Y	Small trees need to be cut.

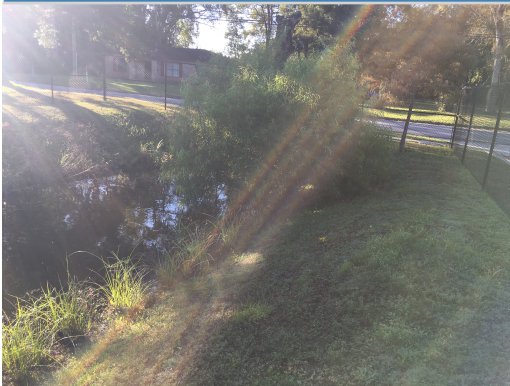
Inspector	Ludwig	Inspection Date	10/26/2021 1:30:00 PM			
Floatables Present	Litter Present	Sediment Accumulation	Debris Accumulation	Outlet Structure Clogged	Outlet Struct. Damaged	Poor Ground Cover
N	N	N	N	N	N	N
Illegal Discharges	Illegal Dumping	Public Hazards	Other	Comments		
N	N	N	Y	Vegetation needs to be removed

Action	Deficiencies noted and maintenance required					
Remove Floatables	Remove Litter	Remove sediment	Remove Debris	Repair Outlet Structure	Repair Ground Cover	Rmv Illegal Discharges
N	N	N	N	N	N	N
Rmv Illegal Dumping	Address Public Hazards	Other	Maint. Request Submitted	Comments		
N	N	N	Y	Vegetation needs to be removed

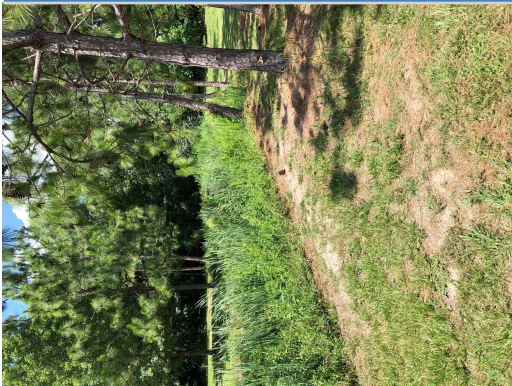
Inspector	Smith	Inspection Date	6/6/2022 7:25:00 PM			
Floatables Present	Litter Present	Sediment Accumulation	Debris Accumulation	Outlet Structure Clogged	Outlet Struct. Damaged	Poor Ground Cover
N	N	N	N	N	N	N
Illegal Discharges	Illegal Dumping	Public Hazards	Other	Comments		
N	N	N	Y	Vegetation needs to be cut.

Action	Deficiencies noted and maintenance required					
Remove Floatables	Remove Litter	Remove sediment	Remove Debris	Repair Outlet Structure	Repair Ground Cover	Rmv Illegal Discharges
N	N	N	N	N	N	N
Rmv Illegal Dumping	Address Public Hazards	Other	Maint. Request Submitted	Comments		
N	N	Y	Y	Vegetation needs to be cut.

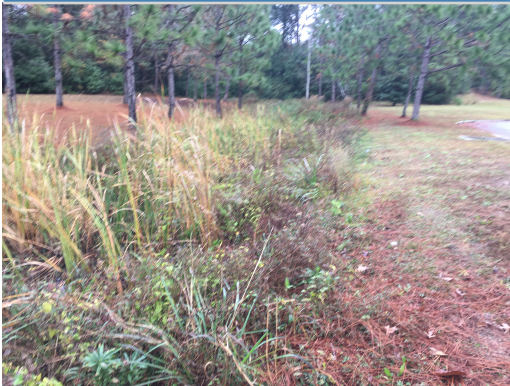
Inspector	Ludwig	Inspection Date	12/7/2021 3:45:00 PM			
Floatables Present	Litter Present	Sediment Accumulation	Debris Accumulation	Outlet Structure Clogged	Outlet Struct. Damaged	Poor Ground Cover
N	N	N	N	N	N	N
Illegal Discharges	Illegal Dumping	Public Hazards	Other	Comments		
N	N	N	Y	Vegetation needs to be cut

Action	Deficiencies noted and maintenance required					
Remove Floatables	Remove Litter	Remove sediment	Remove Debris	Repair Outlet Structure	Repair Ground Cover	Rmv Illegal Discharges
N	N	N	N	N	N	N
Rmv Illegal Dumping	Address Public Hazards	Other	Maint. Request Submitted	Comments		
N	N	Y	Y	Vegetation needs to be cut

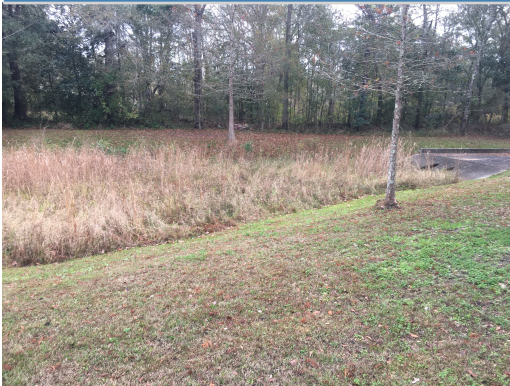
Inspector	Ludwig	Inspection Date	12/14/2021 3:30:00 PM			
Floatables Present	Litter Present	Sediment Accumulation	Debris Accumulation	Outlet Structure Clogged	Outlet Struct. Damaged	Poor Ground Cover
N	N	N	N	N	N	N
Illegal Discharges	Illegal Dumping	Public Hazards	Other	Comments		
N	N	N	Y	Vegetation needs to be cut

Action	Deficiencies noted and maintenance required					
Remove Floatables	Remove Litter	Remove sediment	Remove Debris	Repair Outlet Structure	Repair Ground Cover	Rmv Illegal Discharges
N	N	N	N	N	N	N
Rmv Illegal Dumping	Address Public Hazards	Other	Maint. Request Submitted	Comments		
N	N	Y	Y	Vegetation needs to be cut
