OUTFALL INFORMATION

Investigator:	C. Parker	Outfall ID:	BB - 004
Date & Time:	04/21/2022 at 02:57 PM	Regulated Outfall:	Yes
Watershed:	Bolton Branch	Land Use:	Residential
Latitude:	30.640716	Accuracy (m):	0.8
Longitude:	-88.103787

City of Mobile MS4 Program

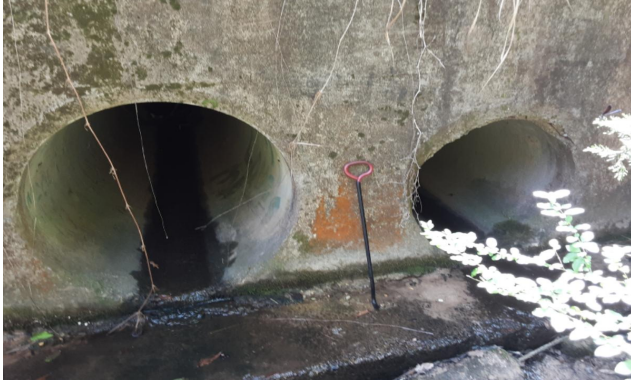
Flow Present:	Yes	Suspect Illicit Discharge:	No
Comments:	Green Algae; 1 barrel is 42", 1 barrel is 36"

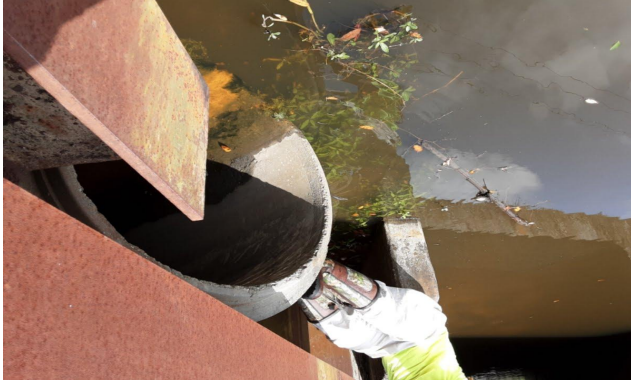
Comments: Iron Oxidizing Bacteria (Algae and Sheen); ,Backwater into outfall;

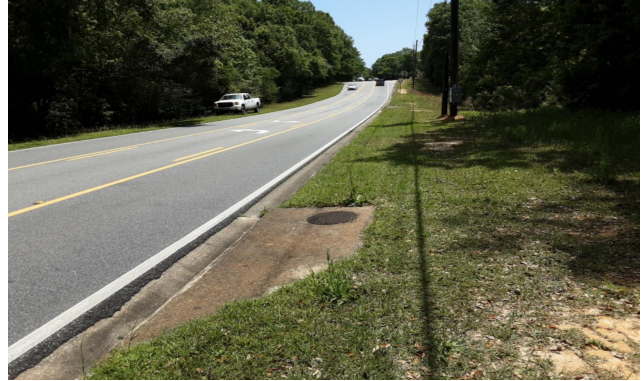
Measured pipe from this inlet

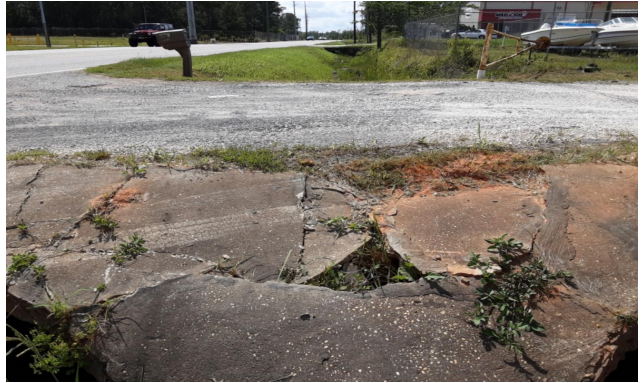
Headwall damage

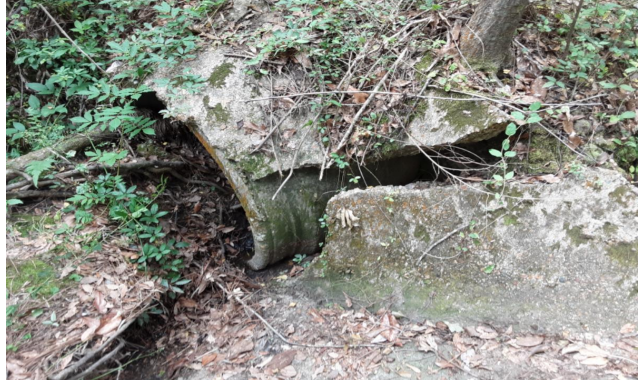
Headwall damage

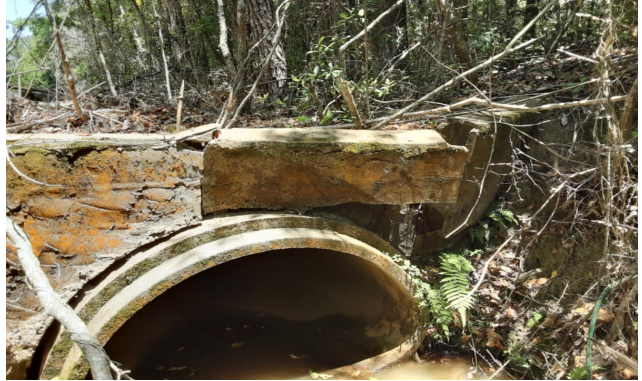
Headwall damage

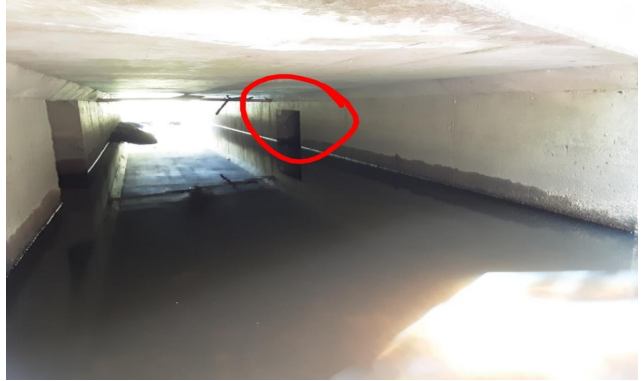
Outfall under road

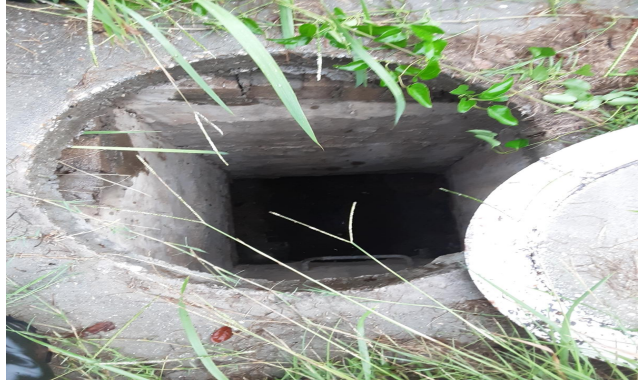
36 inch inlet junction box across street

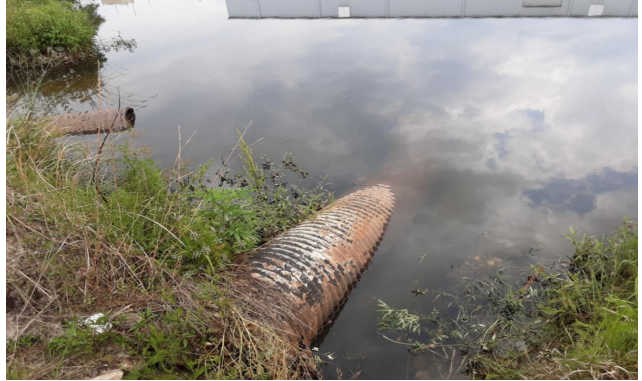
Joints fell into creek
