# City of Mobile MS4 Program

# IDDE Program Outfall Screening Form

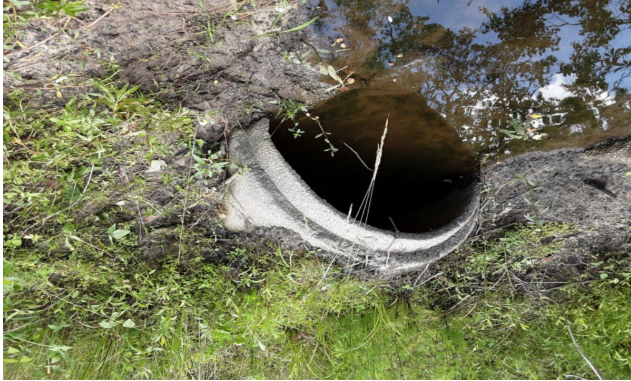
<b>Outfall Type:</b>	Pipe	<b>Condition:</b>	Good
<b>Shape:</b>	Arch	<b>Material:</b>	RCP
<b>Pipe:</b>		<b>Swale:</b>	
Number of Barrels:	1	Depth (ft):	
Diameter (in):		Top Width (ft):	
Width (in):	36	Bottom Width (ft):	
Height (in):	23	<b>Inlet:</b>	
Submerged in Water?	No	Type:	
Submerged in Sediment?	No	Drop Inlet?:	
Outfall Under Structure?	No	Outlet Pipe Diameter:	
Passthrough Culvert?	Yes	<b>Side of Ditch?</b>	Left

<b>Flow Present:</b>	No	<b>Suspect Illicit Discharge:</b>	No
<b>Comments:</b>	Backwater into outfall;

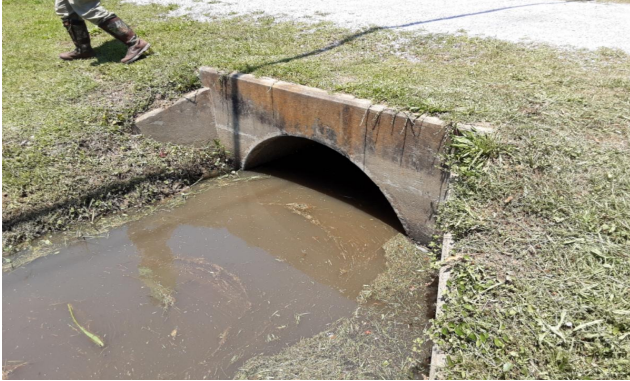
<b>Outfall Type:</b>	Pipe	<b>Condition:</b>	Good
<b>Shape:</b>	Arch	<b>Material:</b>	Concrete
<b>Pipe:</b>		<b>Swale:</b>	
Number of Barrels:	1	Depth (ft):	
Diameter (in):		Top Width (ft):	
Width (in):	65	Bottom Width (ft):	
Height (in):	40	<b>Inlet:</b>	
Submerged in Water?	Partially	Type:	
Submerged in Sediment?	No	Drop Inlet?:	
Outfall Under Structure?	No	Outlet Pipe Diameter:	
Passthrough Culvert?	Yes	<b>Side of Ditch?</b>	Right

<b>Flow Present:</b>	No	<b>Suspect Illicit Discharge:</b>	No
<b>Comments:</b>	Backwater into outfall;

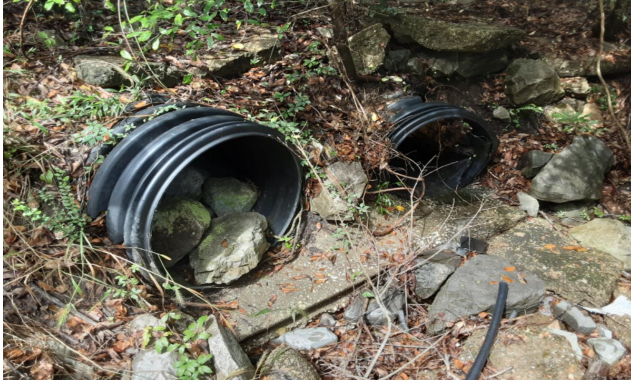
<b>Outfall Type:</b>	Pipe	<b>Condition:</b>	Good
<b>Shape:</b>	Circular	<b>Material:</b>	CPP
<b>Pipe:</b>		<b>Swale:</b>	
Number of Barrels:	2	Depth (ft):	
Diameter (in):	24 & 30	Top Width (ft):	
Width (in):		Bottom Width (ft):	
Height (in):		<b>Inlet:</b>	
Submerged in Water?	No	Type:	
Submerged in Sediment?	No	Drop Inlet?:	
Outfall Under Structure?	No	Outlet Pipe Diameter:	
Passthrough Culvert?	Yes	<b>Side of Ditch?</b>	Right

<b>Flow Present:</b>	Yes	<b>Suspect Illicit Discharge:</b>	No
<b>Comments:</b>	24 inch outfall from detention pond with moderate flow. Separate 30 inch outfall with no flow.

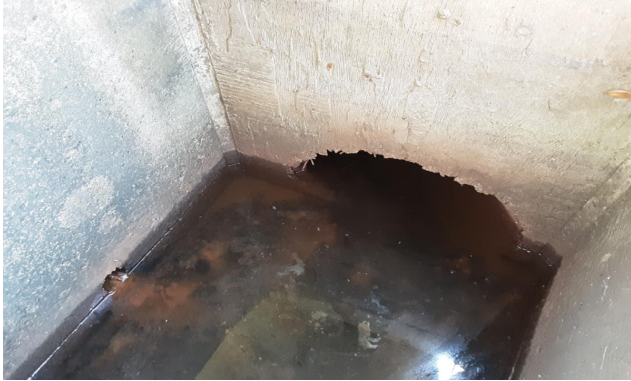
<b>Outfall Type:</b>	Pipe	<b>Condition:</b>	Good
<b>Shape:</b>	Circular	<b>Material:</b>	Concrete
<b>Pipe:</b>		<b>Swale:</b>	
Number of Barrels:	1	Depth (ft):	
Diameter (in):	24	Top Width (ft):	
Width (in):		Bottom Width (ft):	
Height (in):		<b>Inlet:</b>	
Submerged in Water?	Fully	Type:	
Submerged in Sediment?	No	Drop Inlet?:	
Outfall Under Structure?	No	Outlet Pipe Diameter:	
Passthrough Culvert?	No	<b>Side of Ditch?</b>	Left

<b>Flow Present:</b>	No	<b>Suspect Illicit Discharge:</b>	No
<b>Comments:</b>	Backwater into outfall;

Taken at inlet upstream

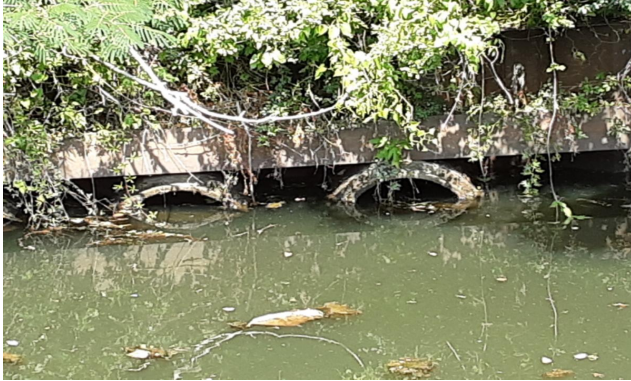
<b>Outfall Type:</b>	Pipe	<b>Condition:</b>	Good
<b>Shape:</b>	Arch	<b>Material:</b>	RCP
<b>Pipe:</b>		<b>Swale:</b>	
Number of Barrels:	2	Depth (ft):	
Diameter (in):		Top Width (ft):	
Width (in):	29	Bottom Width (ft):	
Height (in):	18	<b>Inlet:</b>	
Submerged in Water?	No	Type:	
Submerged in Sediment?	Partially	Drop Inlet?:	
Outfall Under Structure?	No	Outlet Pipe Diameter:	
Passthrough Culvert?	No	<b>Side of Ditch?</b>	Right

<b>Flow Present:</b>	No	<b>Suspect Illicit Discharge:</b>	No
<b>Comments:</b>	Backwater into outfall;

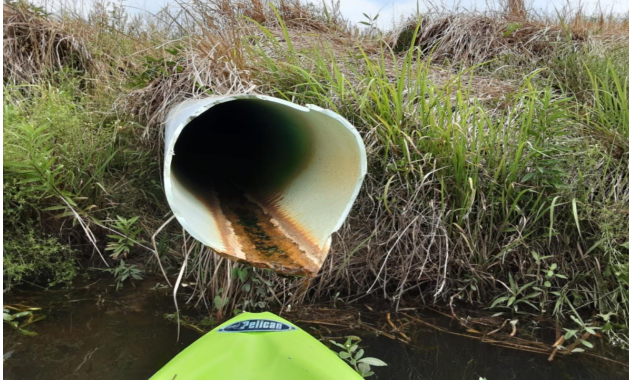
<b>Outfall Type:</b>	Pipe	<b>Condition:</b>	Good
<b>Shape:</b>	Circular	<b>Material:</b>	Concrete
<b>Pipe:</b>		<b>Swale:</b>	
Number of Barrels:	1	Depth (ft):	
Diameter (in):	12	Top Width (ft):	
Width (in):		Bottom Width (ft):	
Height (in):		<b>Inlet:</b>	
Submerged in Water?	No	Type:	
Submerged in Sediment?	No	Drop Inlet?:	
Outfall Under Structure?	No	Outlet Pipe Diameter:	
Passthrough Culvert?	No	<b>Side of Ditch?</b>	Right

<b>Flow Present:</b>	Yes	<b>Suspect Illicit Discharge:</b>	No
<b>Comments:</b>	Green Algae;

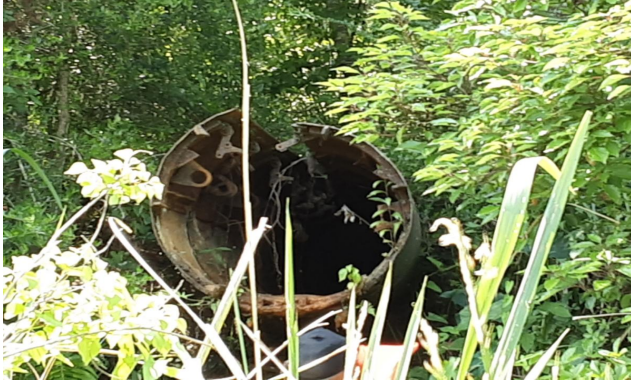
<b>Outfall Type:</b>	Pipe	<b>Condition:</b>	Poor
<b>Shape:</b>	Circular	<b>Material:</b>	CMP
<b>Pipe:</b>		<b>Swale:</b>	
Number of Barrels:	1	Depth (ft):	
Diameter (in):	36	Top Width (ft):	
Width (in):		Bottom Width (ft):	
Height (in):		<b>Inlet:</b>	
Submerged in Water?	No	Type:	
Submerged in Sediment?	No	Drop Inlet?:	
Outfall Under Structure?	No	Outlet Pipe Diameter:	
Passthrough Culvert?	Yes	<b>Side of Ditch?</b>	Left

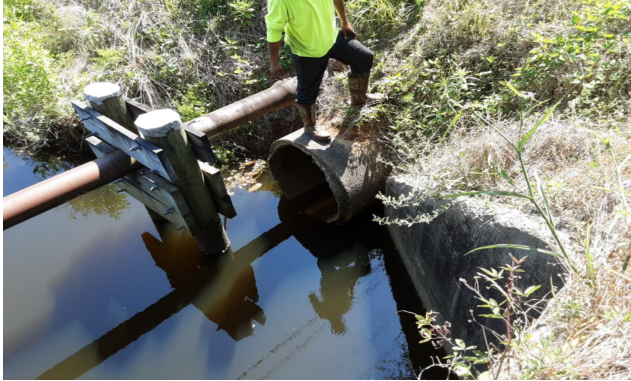
<b>Outfall Type:</b>	Pipe	<b>Condition:</b>	Good
<b>Shape:</b>	Circular	<b>Material:</b>	Concrete
<b>Pipe:</b>		<b>Swale:</b>	
Number of Barrels:	1	Depth (ft):	
Diameter (in):	36	Top Width (ft):	
Width (in):		Bottom Width (ft):	
Height (in):		<b>Inlet:</b>	
Submerged in Water?	No	Type:	
Submerged in Sediment?	No	Drop Inlet?:	
Outfall Under Structure?	No	Outlet Pipe Diameter:	
Passthrough Culvert?	No	<b>Side of Ditch?</b>	Right

<b>Flow Present:</b>	No	<b>Suspect Illicit Discharge:</b>	No
<b>Comments:</b>	Backwater into outfall;

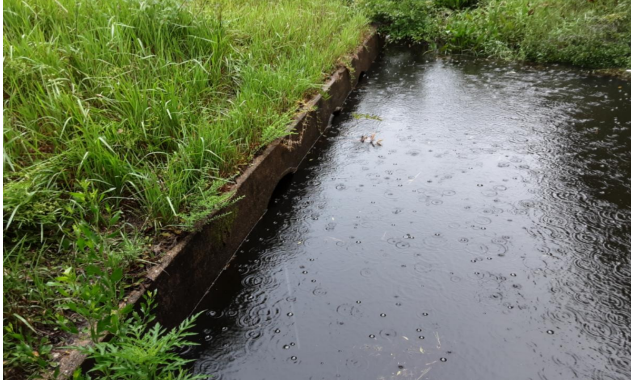
<b>Outfall Type:</b>	Pipe	<b>Condition:</b>	Good
<b>Shape:</b>	Circular	<b>Material:</b>	Concrete
<b>Pipe:</b>		<b>Swale:</b>	
Number of Barrels:	3	Depth (ft):	
Diameter (in):	48	Top Width (ft):	
Width (in):		Bottom Width (ft):	
Height (in):		<b>Inlet:</b>	
Submerged in Water?	Fully	Type:	
Submerged in Sediment?	No	Drop Inlet?:	
Outfall Under Structure?	No	Outlet Pipe Diameter:	
Passthrough Culvert?	Yes	<b>Side of Ditch?</b>	Center

<b>Flow Present:</b>	Yes	<b>Suspect Illicit Discharge:</b>	No
<b>Comments:</b>	WOS;
