OUTFALL INFORMATION

Investigator:	K. Chandler	Outfall ID:	HMC-017
Date & Time:	06/29/2022 at 02:53 PM	Regulated Outfall:	Yes
Watershed:	Halls Mill Creek	Land Use:	Undeveloped
Latitude:	30.606989	Accuracy (m):	0.9
Longitude:	-88.188642

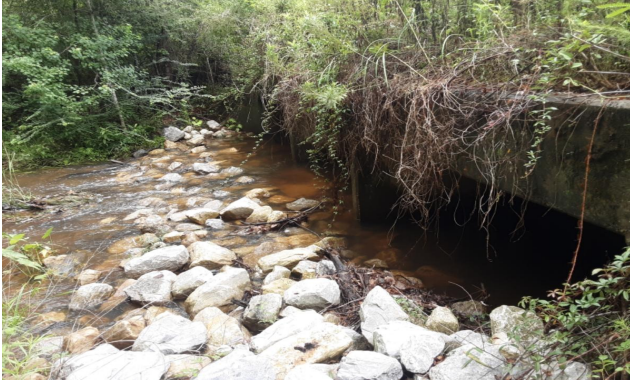
PHOTOGRAPHS

Outfall Type:	Box Culvert	Condition:	Good
Shape:		Material:	RCP
Pipe:		Swale:	
Number of Barrels:	3	Depth (ft):	
Diameter (in):		Top Width (ft):	
Width (in):	120	Bottom Width (ft):	
Height (in):	66	Inlet:	
Submerged in Water?	No	Type:	
Submerged in Sediment?	No	Drop Inlet?:	
Outfall Under Structure?	No	Outlet Pipe Diameter:	
Passthrough Culvert?	Yes	Side of Ditch?	Left

Flow Present:	Yes	Suspect Illicit Discharge:	No
----------------------	-----	-----------------------------------	----

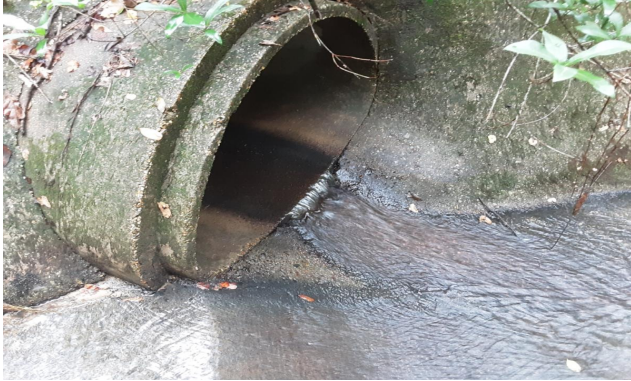
PHOTOGRAPHS

Investigator:	K. Chandler	Outfall ID:	HMC-139
Date & Time:	06/29/2022 at 03:09 PM	Regulated Outfall:	Yes
Watershed:	Halls Mill Creek	Land Use:	Residential
Latitude:	30.625306	Accuracy (m):	0.9
Longitude:	-88.169819

Outfall Type:	Pipe	Condition:	Good
Shape:	Arch	Material:	RCP
Pipe:		Swale:	
Number of Barrels:	1	Depth (ft):	
Diameter (in):		Top Width (ft):	
Width (in):	51	Bottom Width (ft):	
Height (in):	31	Inlet:	
Submerged in Water?	No	Type:	
Submerged in Sediment?	No	Drop Inlet?:	
Outfall Under Structure?	No	Outlet Pipe Diameter:	
Passthrough Culvert?	Yes	Side of Ditch?	Right

Flow Present:	Yes	Suspect Illicit Discharge:	No
----------------------	-----	-----------------------------------	----

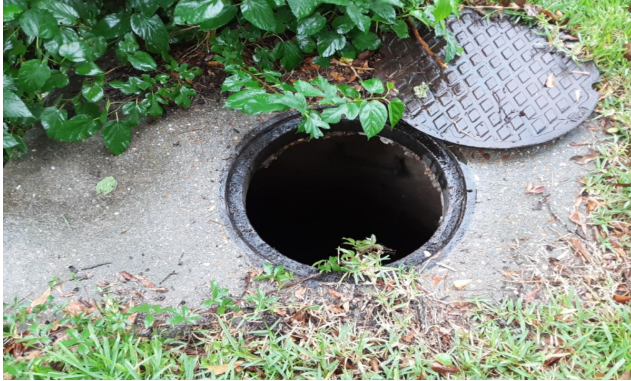
PHOTOGRAPHS

Investigator:	K. Chandler	Outfall ID:	LCC-043
Date & Time:	06/29/2022 at 01:28 PM	Regulated Outfall:	Yes
Watershed:	Lower Chasaw Creek	Land Use:	Residential
Latitude:	30.601715	Accuracy (m):	0.9
Longitude:	-88.060047

Outfall Type:	Pipe	Condition:	Good
Shape:	Arch	Material:	Concrete
Pipe:		Swale:	
Number of Barrels:	1	Depth (ft):	
Diameter (in):		Top Width (ft):	
Width (in):	44	Bottom Width (ft):	
Height (in):	27	Inlet:	
Submerged in Water?	Partially	Type:	
Submerged in Sediment?	No	Drop Inlet?:	
Outfall Under Structure?	Yes	Outlet Pipe Diameter:	
Passthrough Culvert?	No	Side of Ditch?	Left

Flow Present:	Yes	Suspect Illicit Discharge:	No
Comments:	Nearest Accessible Point;

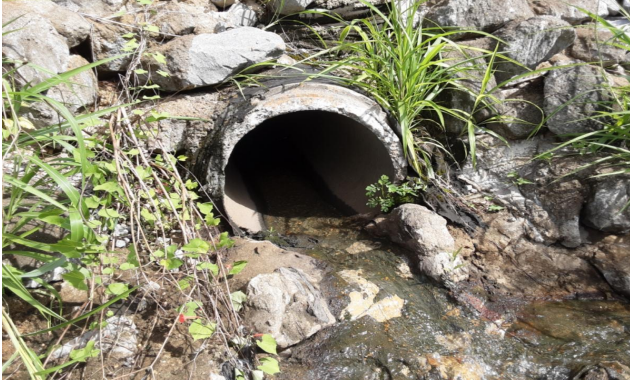
PHOTOGRAPHS

Investigator:	K. Chandler	Outfall ID:	UDR-058
Date & Time:	06/29/2022 at 04:05 PM	Regulated Outfall:	Yes
Watershed:	Upper Dog River	Land Use:	Industrial
Latitude:	30.63819	Accuracy (m):	0.6
Longitude:	-88.127518

Outfall Type:	Pipe	Condition:	Good
Shape:	Circular	Material:	RCP
Pipe:		Swale:	
Number of Barrels:	1	Depth (ft):	
Diameter (in):	21	Top Width (ft):	
Width (in):		Bottom Width (ft):	
Height (in):		Inlet:	
Submerged in Water?	No	Type:	
Submerged in Sediment?	No	Drop Inlet?:	
Outfall Under Structure?	No	Outlet Pipe Diameter:	
Passthrough Culvert?	No	Side of Ditch?	Right

Flow Present:	Yes	Suspect Illicit Discharge:	No
----------------------	-----	-----------------------------------	----
