**Structural Control
Quarterly Inspection**

City of Mobile MS4

Facility ID	Facility Name	Address	Latitude / Longitude
UDR-SC-01	Dredge Spoils Site	3567 Wooley Road	30.61829000 / -88.12593100
Location	Watershed	Land Use	
Public Property	Upper Dog River	Other: Detention area/possible lay-down yard	
Structure Type	Outlet Type		
Retention Pond (Wet)	Pipe

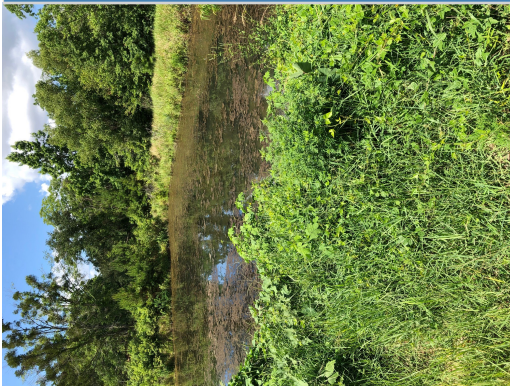
Inspector	Smith	Inspection Date	6/8/2022 3:45:00 PM			
Floatables Present	Litter Present	Sediment Accumulation	Debris Accumulation	Outlet Structure Clogged	Outlet Struct. Damaged	Poor Ground Cover
N	N	N	N	N	N	N
Illegal Discharges	Illegal Dumping	Public Hazards	Other	Comments		
N	N	N	N

Action	No follow-up actions are required					
Remove Floatables	Remove Litter	Remove sediment	Remove Debris	Repair Outlet Structure	Repair Ground Cover	Rmv Illegal Discharges
N	N	N	N	N	N	N
Rmv Illegal Dumping	Address Public Hazards	Other	Maint. Request Submitted	Comments		
N	N	N	N

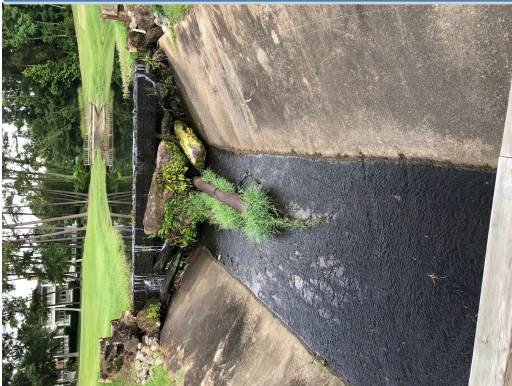
Inspector	Smith	Inspection Date	6/13/2022 2:46:00 PM			
Floatables Present	Litter Present	Sediment Accumulation	Debris Accumulation	Outlet Structure Clogged	Outlet Struct. Damaged	Poor Ground Cover
N	N	N	N	N	N	N
Illegal Discharges	Illegal Dumping	Public Hazards	Other	Comments		
N	N	N	N

Action	No follow-up actions are required					
Remove Floatables	Remove Litter	Remove sediment	Remove Debris	Repair Outlet Structure	Repair Ground Cover	Rmv Illegal Discharges
N	N	N	N	N	N	N
Rmv Illegal Dumping	Address Public Hazards	Other	Maint. Request Submitted	Comments		
N	N	N	N

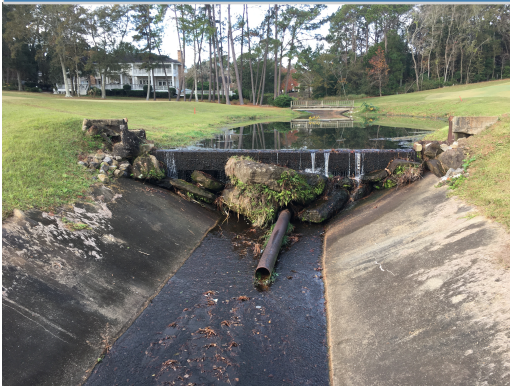
Inspector	Ludwig	Inspection Date	12/6/2021 3:30:00 PM			
Floatables Present	Litter Present	Sediment Accumulation	Debris Accumulation	Outlet Structure Clogged	Outlet Struct. Damaged	Poor Ground Cover
N	N	N	N	N	N	N
Illegal Discharges	Illegal Dumping	Public Hazards	Other	Comments		
N	N	N	N	N/A

Action	No follow-up actions are required					
Remove Floatables	Remove Litter	Remove sediment	Remove Debris	Repair Outlet Structure	Repair Ground Cover	Rmv Illegal Discharges
N	N	N	N	N	N	N
Rmv Illegal Dumping	Address Public Hazards	Other	Maint. Request Submitted	Comments		
N	N	N	N	N/A

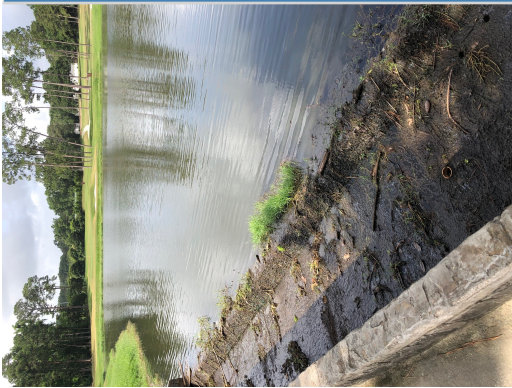
Inspector	Smith	Inspection Date	6/13/2022 2:56:00 PM			
Floatables Present	Litter Present	Sediment Accumulation	Debris Accumulation	Outlet Structure Clogged	Outlet Struct. Damaged	Poor Ground Cover
N	N	N	N	N	N	N
Illegal Discharges	Illegal Dumping	Public Hazards	Other	Comments		
N	N	N	N

Action	No follow-up actions are required					
Remove Floatables	Remove Litter	Remove sediment	Remove Debris	Repair Outlet Structure	Repair Ground Cover	Rmv Illegal Discharges
N	N	N	N	N	N	N
Rmv Illegal Dumping	Address Public Hazards	Other	Maint. Request Submitted	Comments		
N	N	N	N

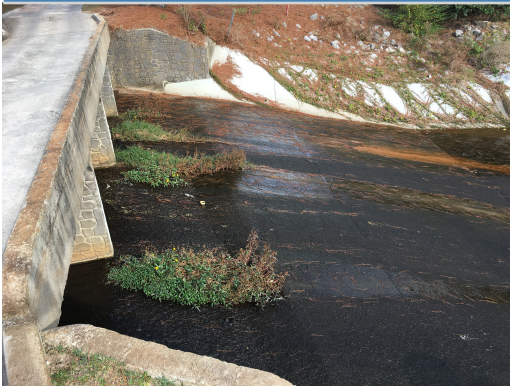
Inspector	Ludwig	Inspection Date	12/6/2021 3:30:00 PM			
Floatables Present	Litter Present	Sediment Accumulation	Debris Accumulation	Outlet Structure Clogged	Outlet Struct. Damaged	Poor Ground Cover
N	N	N	N	N	N	N
Illegal Discharges	Illegal Dumping	Public Hazards	Other	Comments		
N	N	N	N	N/A

Action	No follow-up actions are required					
Remove Floatables	Remove Litter	Remove sediment	Remove Debris	Repair Outlet Structure	Repair Ground Cover	Rmv Illegal Discharges
N	N	N	N	N	N	N
Rmv Illegal Dumping	Address Public Hazards	Other	Maint. Request Submitted	Comments		
N	N	N	N	N/A

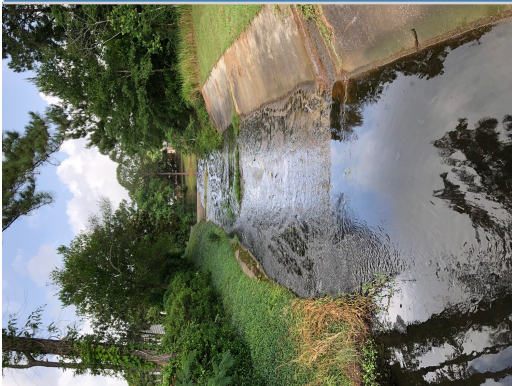
Inspector	Smith	Inspection Date	6/13/2022 2:49:00 PM			
Floatables Present	Litter Present	Sediment Accumulation	Debris Accumulation	Outlet Structure Clogged	Outlet Struct. Damaged	Poor Ground Cover
N	N	N	N	N	N	N
Illegal Discharges	Illegal Dumping	Public Hazards	Other	Comments		
N	N	N	N

Action	No follow-up actions are required					
Remove Floatables	Remove Litter	Remove sediment	Remove Debris	Repair Outlet Structure	Repair Ground Cover	Rmv Illegal Discharges
N	N	N	N	N	N	N
Rmv Illegal Dumping	Address Public Hazards	Other	Maint. Request Submitted	Comments		
N	N	N	N

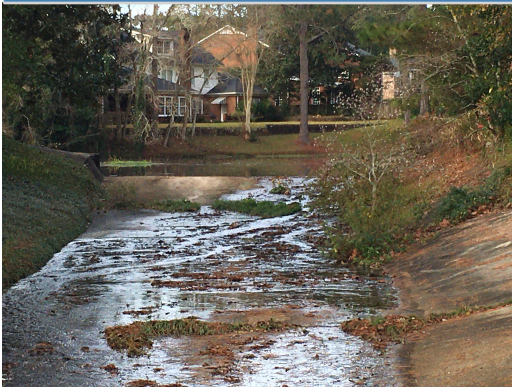
Inspector	Ludwig	Inspection Date	12/6/2021 3:30:00 PM			
Floatables Present	Litter Present	Sediment Accumulation	Debris Accumulation	Outlet Structure Clogged	Outlet Struct. Damaged	Poor Ground Cover
N	N	N	N	N	N	N
Illegal Discharges	Illegal Dumping	Public Hazards	Other	Comments		
N	N	N	N	N/A

Action	No follow-up actions are required					
Remove Floatables	Remove Litter	Remove sediment	Remove Debris	Repair Outlet Structure	Repair Ground Cover	Rmv Illegal Discharges
N	N	N	N	N	N	N
Rmv Illegal Dumping	Address Public Hazards	Other	Maint. Request Submitted	Comments		
N	N	N	N	N/A

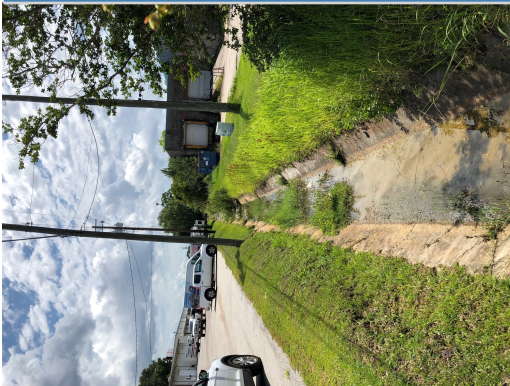
Inspector	Smith	Inspection Date	6/8/2022 4:13:00 PM			
Floatables Present	Litter Present	Sediment Accumulation	Debris Accumulation	Outlet Structure Clogged	Outlet Struct. Damaged	Poor Ground Cover
N	N	N	N	N	N	N
Illegal Discharges	Illegal Dumping	Public Hazards	Other	Comments		
N	N	N	N

Action	No follow-up actions are required					
Remove Floatables	Remove Litter	Remove sediment	Remove Debris	Repair Outlet Structure	Repair Ground Cover	Rmv Illegal Discharges
N	N	N	N	N	N	N
Rmv Illegal Dumping	Address Public Hazards	Other	Maint. Request Submitted	Comments		
N	N	N	N

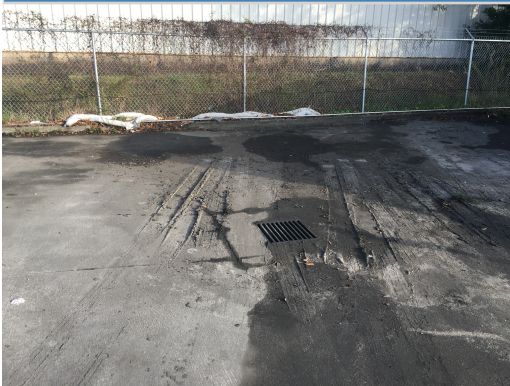
Inspector	Ludwig	Inspection Date	12/28/2021 2:30:00 PM			
Floatables Present	Litter Present	Sediment Accumulation	Debris Accumulation	Outlet Structure Clogged	Outlet Struct. Damaged	Poor Ground Cover
N	N	N	N	N	N	N
Illegal Discharges	Illegal Dumping	Public Hazards	Other	Comments		
N	N	N	N	N/A

Action	No follow-up actions are required					
Remove Floatables	Remove Litter	Remove sediment	Remove Debris	Repair Outlet Structure	Repair Ground Cover	Rmv Illegal Discharges
N	N	N	N	N	N	N
Rmv Illegal Dumping	Address Public Hazards	Other	Maint. Request Submitted	Comments		
N	N	N	N	N/A

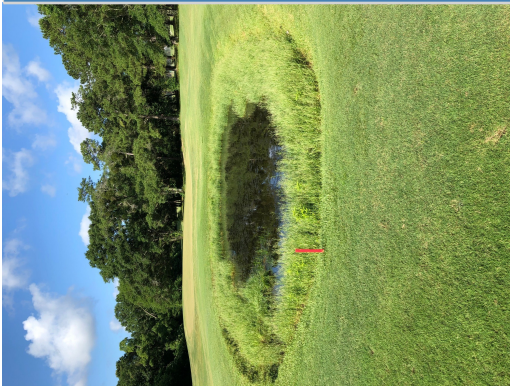
Inspector	Smith	Inspection Date	6/8/2022 1:56:00 PM			
Floatables Present	Litter Present	Sediment Accumulation	Debris Accumulation	Outlet Structure Clogged	Outlet Struct. Damaged	Poor Ground Cover
N	N	N	N	N	N	N
Illegal Discharges	Illegal Dumping	Public Hazards	Other	Comments		
N	N	N	N

Action	No follow-up actions are required					
Remove Floatables	Remove Litter	Remove sediment	Remove Debris	Repair Outlet Structure	Repair Ground Cover	Rmv Illegal Discharges
N	N	N	N	N	N	N
Rmv Illegal Dumping	Address Public Hazards	Other	Maint. Request Submitted	Comments		
N	N	N	N

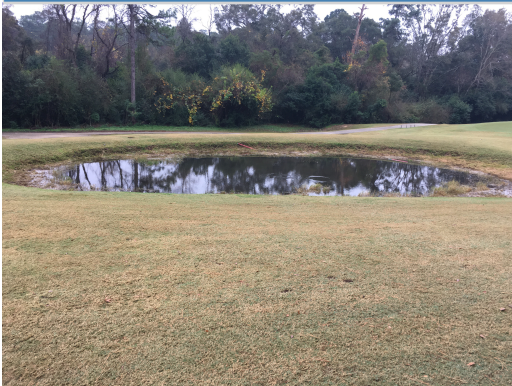
Inspector	Ludwig	Inspection Date	12/7/2021 3:30:00 PM			
Floatables Present	Litter Present	Sediment Accumulation	Debris Accumulation	Outlet Structure Clogged	Outlet Struct. Damaged	Poor Ground Cover
N	N	N	N	N	N	N
Illegal Discharges	Illegal Dumping	Public Hazards	Other	Comments		
N	N	N	N	N/A

Action	No follow-up actions are required					
Remove Floatables	Remove Litter	Remove sediment	Remove Debris	Repair Outlet Structure	Repair Ground Cover	Rmv Illegal Discharges
N	N	N	N	N	N	N
Rmv Illegal Dumping	Address Public Hazards	Other	Maint. Request Submitted	Comments		
N	N	N	N	N/A

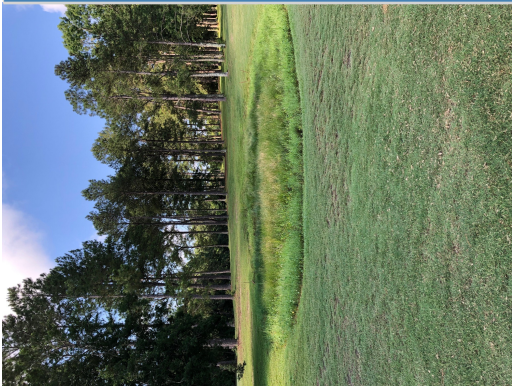
Inspector	Smith	Inspection Date	6/8/2022 1:53:00 PM			
Floatables Present	Litter Present	Sediment Accumulation	Debris Accumulation	Outlet Structure Clogged	Outlet Struct. Damaged	Poor Ground Cover
N	N	N	N	N	N	N
Illegal Discharges	Illegal Dumping	Public Hazards	Other	Comments		
N	N	N	N

Action	No follow-up actions are required					
Remove Floatables	Remove Litter	Remove sediment	Remove Debris	Repair Outlet Structure	Repair Ground Cover	Rmv Illegal Discharges
N	N	N	N	N	N	N
Rmv Illegal Dumping	Address Public Hazards	Other	Maint. Request Submitted	Comments		
N	N	N	N

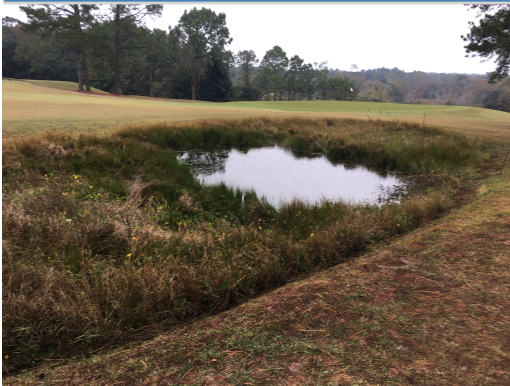
Inspector	Ludwig	Inspection Date	12/7/2021 3:15:00 PM			
Floatables Present	Litter Present	Sediment Accumulation	Debris Accumulation	Outlet Structure Clogged	Outlet Struct. Damaged	Poor Ground Cover
N	N	N	N	N	N	N
Illegal Discharges	Illegal Dumping	Public Hazards	Other	Comments		
N	N	N	N	N/A

Action	No follow-up actions are required					
Remove Floatables	Remove Litter	Remove sediment	Remove Debris	Repair Outlet Structure	Repair Ground Cover	Rmv Illegal Discharges
N	N	N	N	N	N	N
Rmv Illegal Dumping	Address Public Hazards	Other	Maint. Request Submitted	Comments		
N	N	N	N	N/A

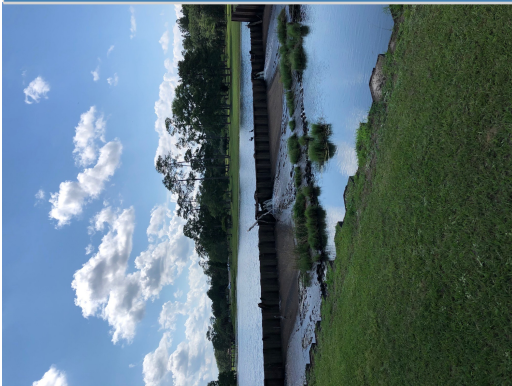
Inspector	Smith	Inspection Date	6/6/2022 8:20:00 PM			
Floatables Present	Litter Present	Sediment Accumulation	Debris Accumulation	Outlet Structure Clogged	Outlet Struct. Damaged	Poor Ground Cover
N	N	N	N	N	N	N
Illegal Discharges	Illegal Dumping	Public Hazards	Other	Comments		
N	N	N	N

Action	No follow-up actions are required					
Remove Floatables	Remove Litter	Remove sediment	Remove Debris	Repair Outlet Structure	Repair Ground Cover	Rmv Illegal Discharges
N	N	N	N	N	N	N
Rmv Illegal Dumping	Address Public Hazards	Other	Maint. Request Submitted	Comments		
N	N	N	N

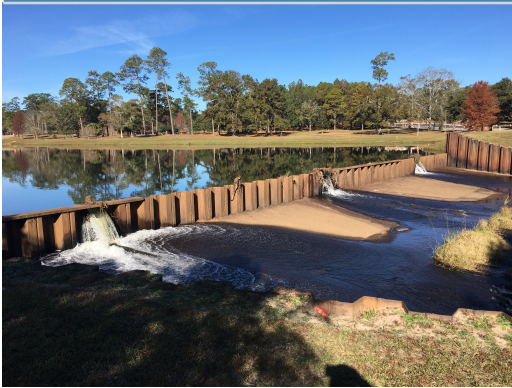
Inspector	Ludwig	Inspection Date	12/1/2021 3:30:00 PM			
Floatables Present	Litter Present	Sediment Accumulation	Debris Accumulation	Outlet Structure Clogged	Outlet Struct. Damaged	Poor Ground Cover
N	N	N	N	N	N	N
Illegal Discharges	Illegal Dumping	Public Hazards	Other	Comments		
N	N	N	N	N/A

Action	No follow-up actions are required					
Remove Floatables	Remove Litter	Remove sediment	Remove Debris	Repair Outlet Structure	Repair Ground Cover	Rmv Illegal Discharges
N	N	N	N	N	N	N
Rmv Illegal Dumping	Address Public Hazards	Other	Maint. Request Submitted	Comments		
N	N	N	N	N/A

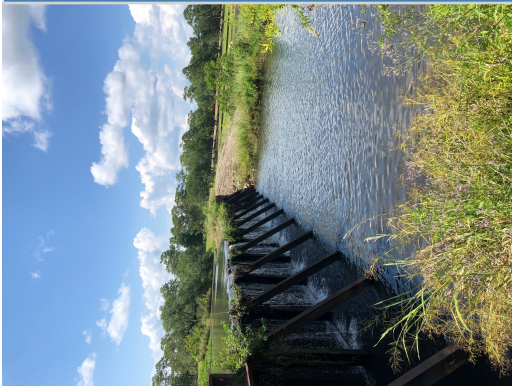
Inspector	Smith	Inspection Date	6/6/2022 8:28:00 PM			
Floatables Present	Litter Present	Sediment Accumulation	Debris Accumulation	Outlet Structure Clogged	Outlet Struct. Damaged	Poor Ground Cover
N	N	N	N	N	N	N
Illegal Discharges	Illegal Dumping	Public Hazards	Other	Comments		
N	N	N	N

Action	No follow-up actions are required					
Remove Floatables	Remove Litter	Remove sediment	Remove Debris	Repair Outlet Structure	Repair Ground Cover	Rmv Illegal Discharges
N	N	N	N	N	N	N
Rmv Illegal Dumping	Address Public Hazards	Other	Maint. Request Submitted	Comments		
N	N	N	N

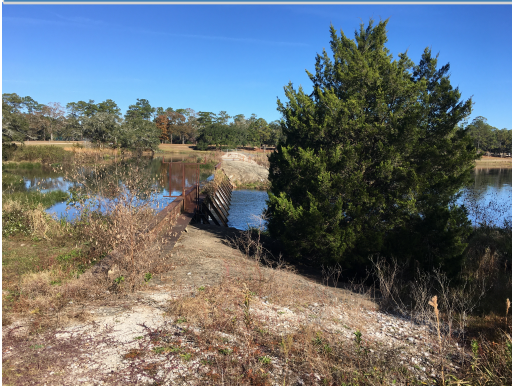
Inspector	Ludwig	Inspection Date	12/1/2021 3:45:00 PM			
Floatables Present	Litter Present	Sediment Accumulation	Debris Accumulation	Outlet Structure Clogged	Outlet Struct. Damaged	Poor Ground Cover
N	N	N	N	N	N	N
Illegal Discharges	Illegal Dumping	Public Hazards	Other	Comments		
N	N	N	N	N/A

Action	No follow-up actions are required					
Remove Floatables	Remove Litter	Remove sediment	Remove Debris	Repair Outlet Structure	Repair Ground Cover	Rmv Illegal Discharges
N	N	N	N	N	N	N
Rmv Illegal Dumping	Address Public Hazards	Other	Maint. Request Submitted	Comments		
N	N	N	N	N/A

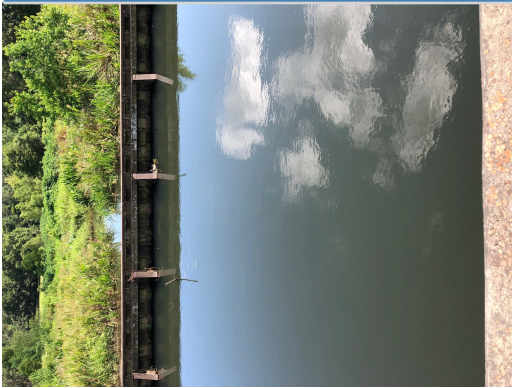
Inspector	Smith	Inspection Date	6/6/2022 8:31:00 PM			
Floatables Present	Litter Present	Sediment Accumulation	Debris Accumulation	Outlet Structure Clogged	Outlet Struct. Damaged	Poor Ground Cover
N	N	N	N	N	N	N
Illegal Discharges	Illegal Dumping	Public Hazards	Other	Comments		
N	N	N	N

Action	No follow-up actions are required					
Remove Floatables	Remove Litter	Remove sediment	Remove Debris	Repair Outlet Structure	Repair Ground Cover	Rmv Illegal Discharges
N	N	N	N	N	N	N
Rmv Illegal Dumping	Address Public Hazards	Other	Maint. Request Submitted	Comments		
N	N	N	N

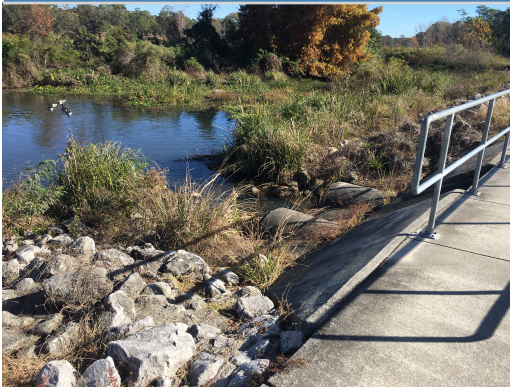
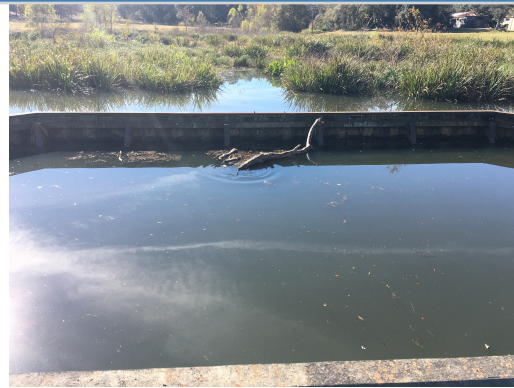
Inspector	Ludwig	Inspection Date	12/1/2021 3:45:00 PM			
Floatables Present	Litter Present	Sediment Accumulation	Debris Accumulation	Outlet Structure Clogged	Outlet Struct. Damaged	Poor Ground Cover
N	N	N	N	N	N	N
Illegal Discharges	Illegal Dumping	Public Hazards	Other	Comments		
N	N	N	N	N/A

Action	No follow-up actions are required					
Remove Floatables	Remove Litter	Remove sediment	Remove Debris	Repair Outlet Structure	Repair Ground Cover	Rmv Illegal Discharges
N	N	N	N	N	N	N
Rmv Illegal Dumping	Address Public Hazards	Other	Maint. Request Submitted	Comments		
N	N	N	N	N/A

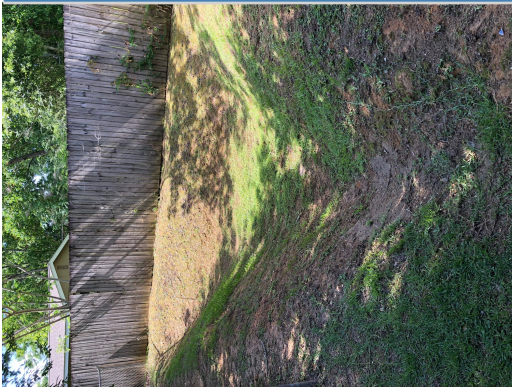
Inspector	Smith	Inspection Date	6/8/2022 2:22:00 PM			
Floatables Present	Litter Present	Sediment Accumulation	Debris Accumulation	Outlet Structure Clogged	Outlet Struct. Damaged	Poor Ground Cover
N	N	N	N	N	N	N
Illegal Discharges	Illegal Dumping	Public Hazards	Other	Comments		
N	N	N	N

Action	No follow-up actions are required					
Remove Floatables	Remove Litter	Remove sediment	Remove Debris	Repair Outlet Structure	Repair Ground Cover	Rmv Illegal Discharges
N	N	N	N	N	N	N
Rmv Illegal Dumping	Address Public Hazards	Other	Maint. Request Submitted	Comments		
N	N	N	N
