OUTFALL INFORMATION

Investigator:	C. Parker	Outfall ID:	BB - 004
Date & Time:	04/21/2022 at 02:57 PM	Regulated Outfall:	Yes
Watershed:	Bolton Branch	Land Use:	Residential
Latitude:	30.640716	Accuracy (m):	0.8
Longitude:	-88.103787

City of Mobile MS4 Program

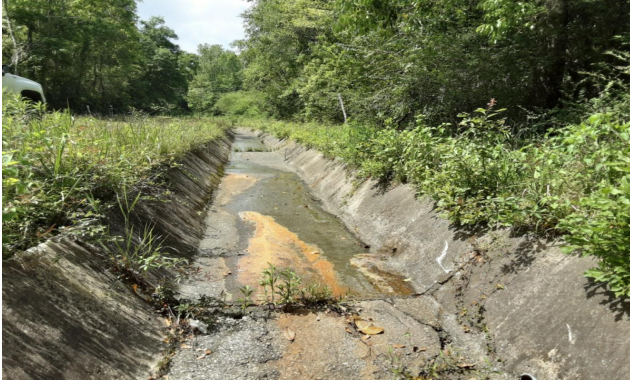
Outfall Type:	Swale	Condition:	Good
Shape:	Trapezoid	Material:	Concrete
Pipe:		Swale:	
Number of Barrels:		Depth (ft):	2.0
Diameter (in):		Top Width (ft):	9.0
Width (in):		Bottom Width (ft):	7.0
Height (in):		Inlet:	
Submerged in Water?		Type:	
Submerged in Sediment?		Drop Inlet?:	
Outfall Under Structure?		Outlet Pipe Diameter:	
Passthrough Culvert?		Side of Ditch?	Right

Wet bottom, no flow

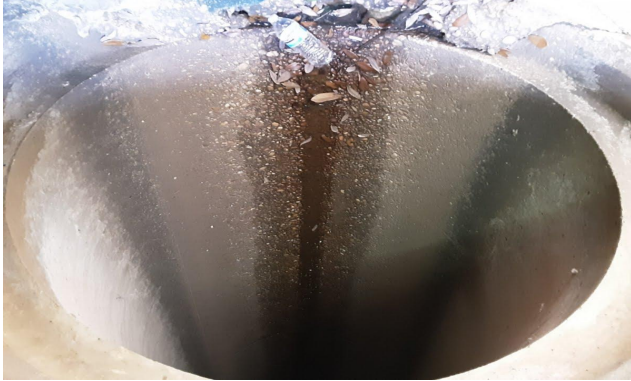
Measured pipe from this inlet

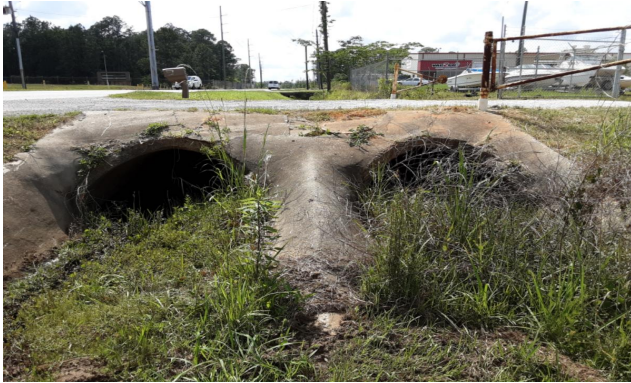
Outfall Type:	Pipe	Condition:	Fair
Shape:	Arch	Material:	Concrete
Pipe:		Swale:	
Number of Barrels:	2	Depth (ft):	
Diameter (in):		Top Width (ft):	
Width (in):	65	Bottom Width (ft):	
Height (in):	40	Inlet:	
Submerged in Water?	No	Type:	
Submerged in Sediment?	Partially	Drop Inlet?:	
Outfall Under Structure?	Yes	Outlet Pipe Diameter:	
Passthrough Culvert?	Yes	Side of Ditch?	Right

Headwall damage

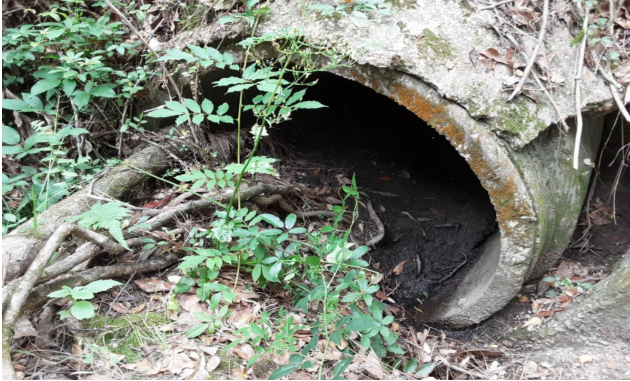
Outfall Type:	Pipe	Condition:	Fair
Shape:	Circular	Material:	Concrete
Pipe:		Swale:	
Number of Barrels:	1	Depth (ft):	
Diameter (in):	42	Top Width (ft):	
Width (in):		Bottom Width (ft):	
Height (in):		Inlet:	
Submerged in Water?	No	Type:	
Submerged in Sediment?	No	Drop Inlet?:	
Outfall Under Structure?	No	Outlet Pipe Diameter:	
Passthrough Culvert?	No	Side of Ditch?	Left

Headwall damage

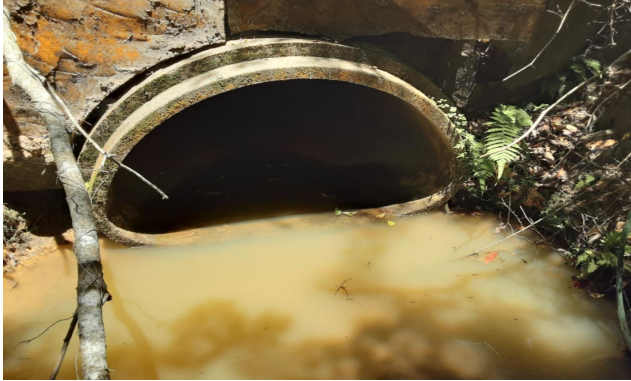
Outfall Type:	Pipe	Condition:	Fair
Shape:	Arch	Material:	Concrete
Pipe:		Swale:	
Number of Barrels:	1	Depth (ft):	
Diameter (in):		Top Width (ft):	
Width (in):	65	Bottom Width (ft):	
Height (in):	40	Inlet:	
Submerged in Water?	No	Type:	
Submerged in Sediment?	No	Drop Inlet?:	
Outfall Under Structure?	No	Outlet Pipe Diameter:	
Passthrough Culvert?	No	Side of Ditch?	Right

Headwall damage

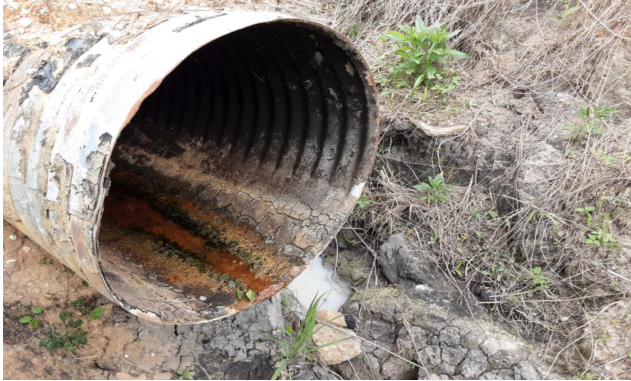
Joints fell into creek

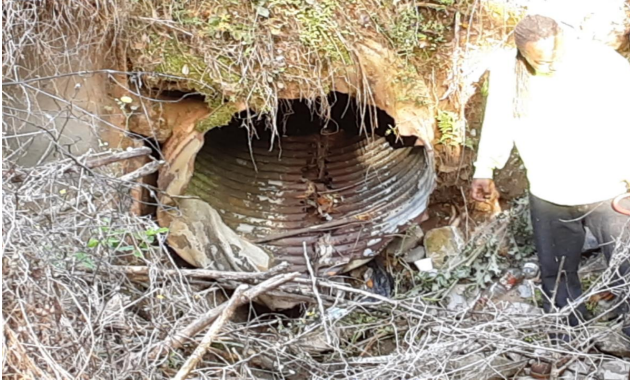
Comments: None Bottom has partially rusted away
